INVESTIGATION OF THE A-7 HOOK POINT
ATTACHMENT BOLT LOOSENING PROBLEM

THESIS

December 1974

MASTER OF SCIENCE IN AERONAUTICAL ENGINEERING

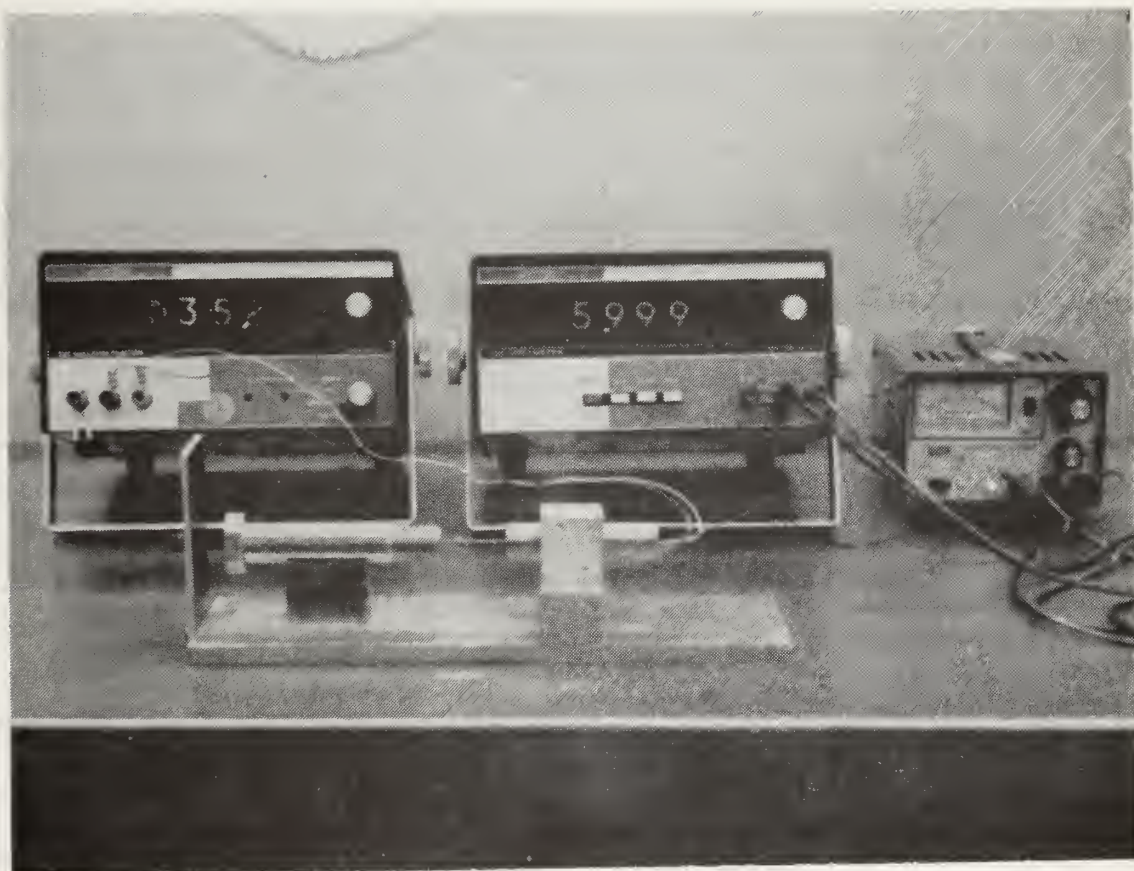
Figure 19. The measuring setup with the L.V.D.T. in the foreground.

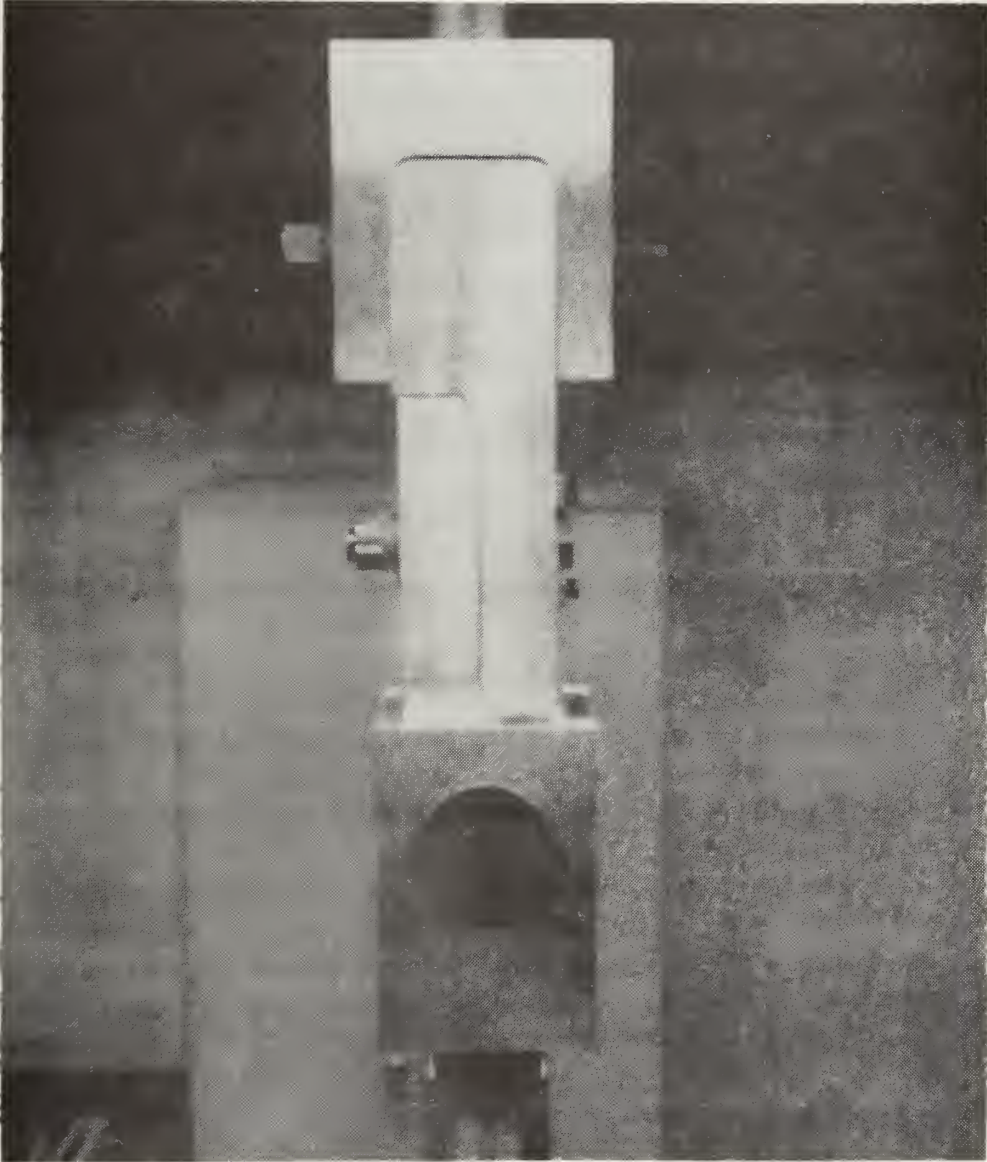
Figure 20. The test fixture.
